Debugging a Mixed Signal Design with a Tektronix Mixed Signal Oscilloscope

Application Note

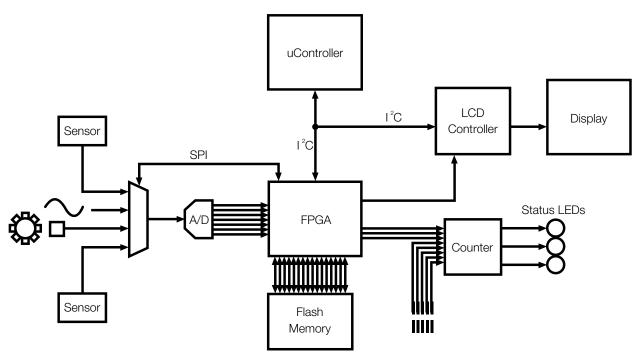
Figure 1. Mixed Signal Embedded System.

Microprocessors, FPGAs, Analog-to-Digital Converters (ADC), and Digital-to-Analog Converters (DAC) are all examples of ICs that present unique measurement challenges in today's embedded designs. The engineer may need to decode a SPI bus between two ICs while observing the input and output of an ADC at the same time, on the same system board. An example of such a mixed-signal system is shown in Figure 1.

Debugging the hardware shown in Figure 1 is a difficult and somewhat daunting task to the engineer who is armed with his favorite 4-channel oscilloscope. Many engineers feel comfortable with their oscilloscope, and in the interest of saving time, may choose to acquire 3 or 4 oscilloscopes in order to probe multiple signals at once. Logic analyzers provide the ability to probe many digital signals, but the complexity of the debug task may not merit the setup and learning curve required to use the logic analyzer. Fortunately for engineers faced with this task, the Tektronix MSO5000, MSO4000, MSO3000 and MSO2000 Series Mixed Signal Oscilloscopes (MSO) and MDO4000 Series Mixed Domain Oscilloscopes (MDO) can address their needs. The Tektronix MSO Series combines the basic functionality of a 16-channel logic analyzer with the trusted performance of a 4-channel

Although DPO Series oscilloscopes can provide up to four channels for probing serial data, several of the common serial protocols require three wires or more. Engineers often need the ability to decode and display multiple serial buses at the same time, and observe their timing correlation. The Tektronix MSO/MDO Series combines the serial trigger and decode power of the DPO Series with 16 additional digital channels. In addition to I²C, SPI, CAN, LIN, RS-232 and other serial bus standards, the MSO/MDO Series supports triggering and decoding parallel buses. With the MSO/MDO Series of oscilloscopes, engineers can probe and decode multiple serial buses along with custom parallel buses, all at the same time. In the following example, an MSO/MDO Series was used to debug a complex, multi-chip communication error for the embedded design shown in Figure 1.

During the initial debug of the system (shown in Figure 1), the system occasionally encountered a condition where the status LEDs on the circuit board indicated a failure. The ambiguous error reported by the status LEDs left the system engineer unsure if the problem was hardware or software related. A similar error had previously been the result of poor signal quality at the input of the analog MUX, but the hardware that caused the signal fidelity problem had been successfully replaced. Since the system engineer was suspicious that the error could be coming from a source other than the MUX input, he decided to get a broad system view by probing the analog input to the MUX as well as several digital buses. With 4 analog and 16 digital channels available for debugging, the MSO/MDO Series was connected to the signals labeled 1-4 in Figure 2.

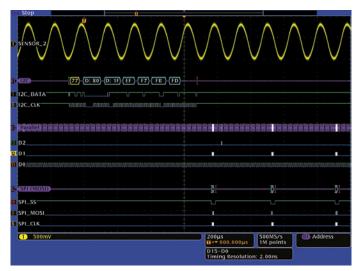
Figure 3. MSO4000 displaying I2C, SPI, and parallel buses with CH1 analog.

Figure 3 shows a screenshot from probing the SPI bus (1), I²C bus (2), 3-bit parallel bus (3), and analog input (4) at the same time. Since the error could be isolated to a particular subroutine, the oscilloscope was configured to take a single acquisition that triggered on particular I²C activity. Setting the record length to 1M points guaranteed that all the useful information around the event on the I2C bus would be accurately captured. The engineer ran the subroutine and quickly referred to the MSO/MDO Series to see what had happened in the system. The clean analog waveform at the input of the MUX shown on CH1 confirmed the engineer's suspicion that the hardware had been fixed, and the error was occurring elsewhere. The oscilloscope triggered on and decoded the I²C data being written from the microcontroller. The engineer noticed activity on the SPI bus and the displayed signals labeled D1 and D2 shortly after the I2C data was transmitted. The activity on these buses was suspicious because the executed function was supposed to primarily involve the LCD controller. Because the oscilloscope had already decoded the value of the I²C data, the engineer could see that the microcontroller had written I2C data to address

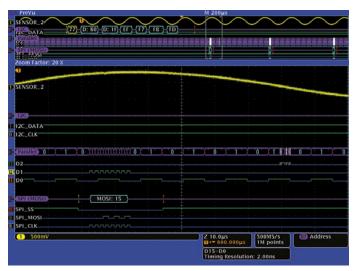
Figure 4. Wave Inspector® is used to zoom in and show packet detail.

0x77. Address 0x77 is the address of the FPGA, but the subroutine was supposed to write data to address 0x76 instead, which is the address of the LCD controller. Figure 4 shows the same acquisition while using Wave Inspector® Navigation and Search to zoom in on the details of the SPI and parallel buses. The SPI data is decoded on screen as a write from the master (FPGA) to the slave (MUX) with a data value of 0x15. This SPI command instructed the input MUX to change the input it was using for the signal path. This unexpected change in the input signal caused the FPGA to send an error code to the status LEDs on the parallel bus. The activity on signal D2 indicating the error code and the decoding of the parallel bus can be observed in Figure 4 as well. The embedded design engineer was quickly able to determine that a software bug had caused the malfunction in the system because the MSO/MDO Series oscilloscope was able to view and decode all the signals of interest simultaneously. The software programmer had mistakenly written I²C data from the microcontroller to the FPGA when the packet was intended for the LCD controller.

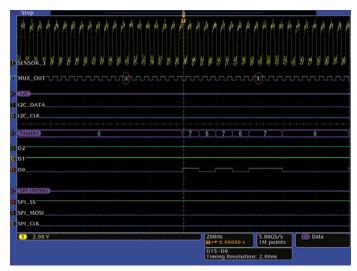
Figure 5. The white edges on MUX_OUT indicate more details are present.

The FPGA transmits value 0x7 over the 3-bit parallel bus to indicate an error has occurred. In order to isolate the problem, the MSO/MDO Series was configured to capture a single acquisition with the trigger event set to parallel bus value 0x7. Figure 5 shows the resulting acquisition. In this case, the parallel bus decoding and trigger saved time and confusion because the error condition was easily isolated. The 1M record length used during this acquisition allowed the engineer to observe key details of the signals before and after the trigger event.

At first glance, the signals shown in Figure 5 appear to be well behaved, but the system engineer quickly identified two edge transitions on the MUX_OUT signal that appeared unique. The white transitions on the MUX_OUT signal shown in Figure 5 are an indication to the user that more information exists within those portions of the signal. The MSO/MDO Series multiple edge detection capability highlights areas of the waveform where zooming may reveal higher frequency digital pulses. Figure 6 reveals the details behind the first white transition when Wave Inspector® is used to zoom in on the waveform details. The portion of the signal that was drawn as the white transition in Figure 5 is a glitch on the MUX_OUT signal.

he monitored in Figure 5 were identified as the source of crosstalk. While examining the circuit board layout in more detail, the engineer found a via located next to the MUX_OUT trace on the printed circuit board (PCB). The engineer probed the via on the PCB with CH1, and waited for another trigger from the parallel bus. The resulting screenshot is shown in Figure 8. Figure 8 shows that a low to high transition for the signal captured on CH1 directly correlates in time with a positive glitch on the MUX_OUT signal. Correspondingly, the high to low transition directly relates to a negative glitch on the MUX_OUT signal.

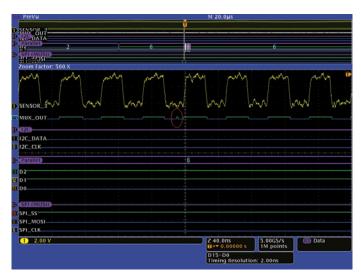
Figure 6. Wave Inspector® reveals a glitch on the MUX_OUT signal.

Figure 6 shows the timing correlation between the analog and digital channels in the MSO/MDO Series. The input to the MUX is displayed on CH1 (SENSOR_3) while the MUX output is observed on digital channel D14 (MUX_OUT). The engineer noticed that although the MUX output had a glitch, the input to the MUX appeared glitch free. After identifying the glitch with the digital channel, the engineer decided to take a closer look by connecting CH2 to the MUX output. Figure 7 shows the resulting acquisition with the oscilloscope still configured to trigger on the parallel bus value 0x7. The waveforms for the SPI and I²C buses have been turned off in Figure 7 to focus on the primary signals of interest. Using the analog probes on the

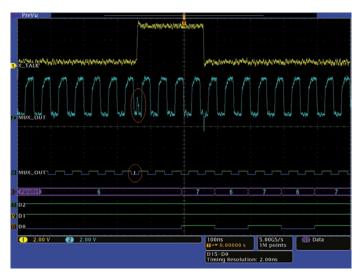
Figure 8. CH1 shows the source of crosstalk into the MUX_OUT signal.

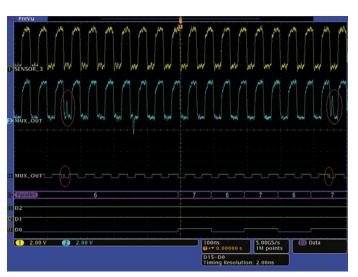
Figure 7. CH2 shows more detail for MUX_OUT.

MUX input and output revealed that glitches present on the output are not present on the input signal. Figure 7 shows that a glitch on the MUX_OUT signal appeared a short time before the FPGA sent the error code. The timing relationship between these two signals indicated that the glitch could be the problem the engineer had observed. The engineer repeated the acquisition several times with the same configuration, and observed behavior similar to Figure 7 in every case.

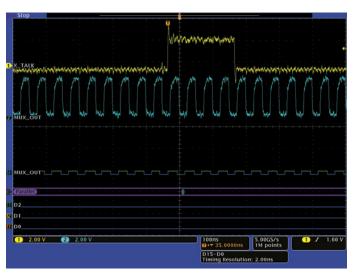
Figure 9. The PCB modification removes the crosstalk.

After spending some time to reroute the offending signal on the circuit board, the engineer configured the MSO/MDO Series oscilloscope to trigger on CH1. Figure 9 shows that the MSO/MDO Series triggered on the CH1 transition, but does not show a glitch on the MUX_OUT signal. Since the MUX_OUT signal did not have a glitch present, the parallel bus did not produce an error condition. The circuit board modification removed the crosstalk, and allowed the embedded design engineer to complete his system evaluation.
